# Tree survey at xxx

Prepared for xxx

28<sup>th</sup> June, 2012

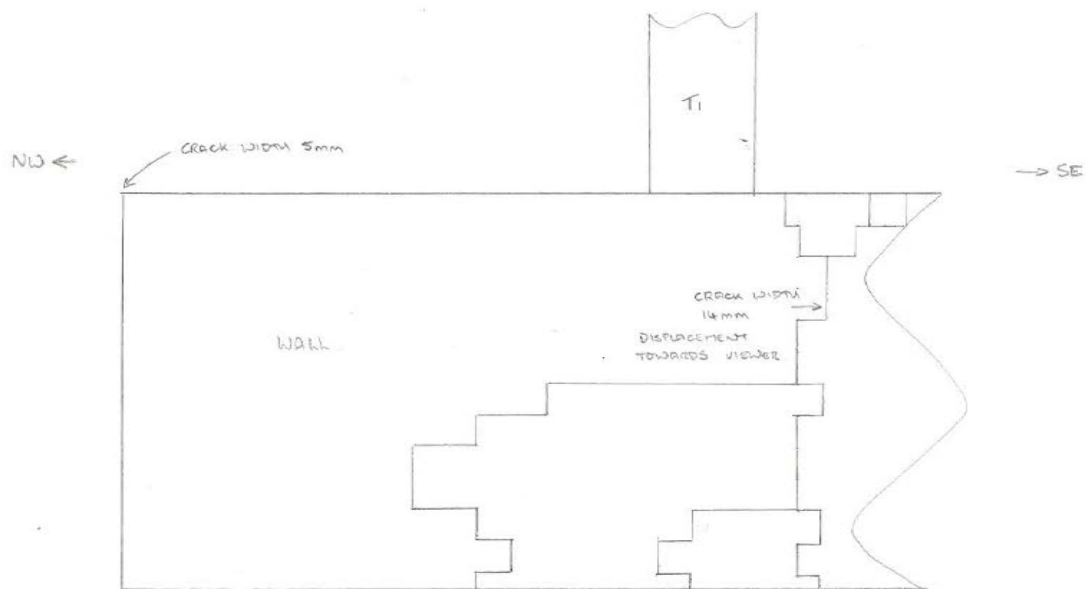
- Wall of modern brick with older capstones built on concrete strip foundation of unknown depth. Style of brick is consistent with that used in the construction of the house at xxx. The house was constructed c.1991 and it seems reasonable to assume that the wall is of a similar age.
- Gap between tree and wall is 140mm at narrowest point and 250mm at widest. Gap full of wood / brick which contacts both tree and wall.
- Crack starts at top of wall immediately to east of tree and follows brick courses to ground level immediately below and to the west of the tree.
- Damaged section displaced towards south west by 12mm.
- Crack at right-angled intersection of wall with next garden wall 5mm wide. Walls not keyed in together.

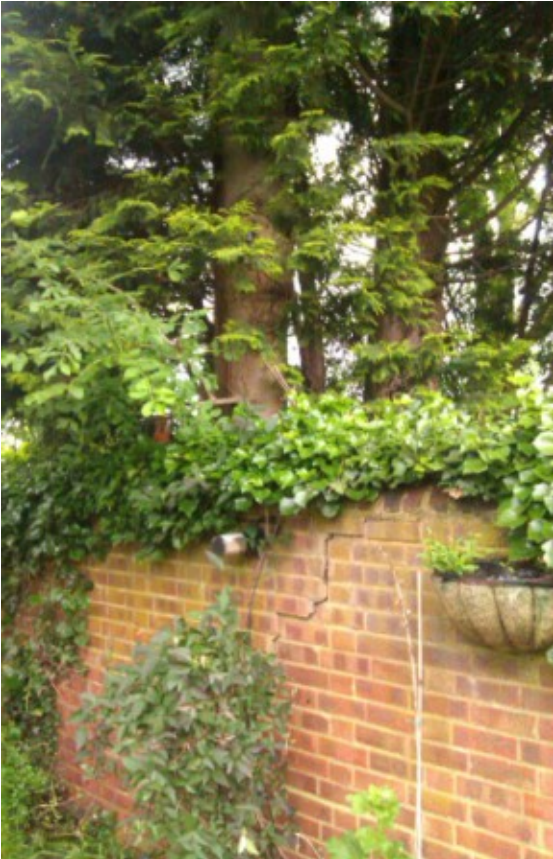
- Consequently, the wall has been damaged by the combined effects of the growth habit of T1 and the presence of material between the tree and the wall.

Fig. 1: General view of trees T1 & T2 and the damaged wall.

- Communicate these findings to xxx and ask that she takes action to resolve the situation and repair the damage caused.
  - The most cost-effective solution would be to remove T1 and re-build the boundary wall along its current line. There would thus be no possibility of a problem arising from T1 in the future.

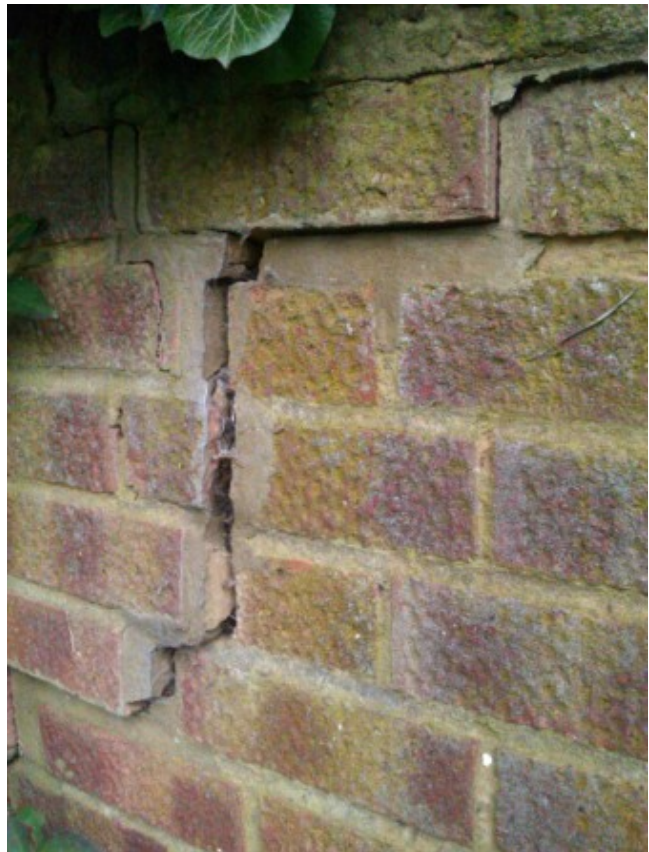
Fig. 2: Close-up of damage showing displacement by 12mm to the south west.

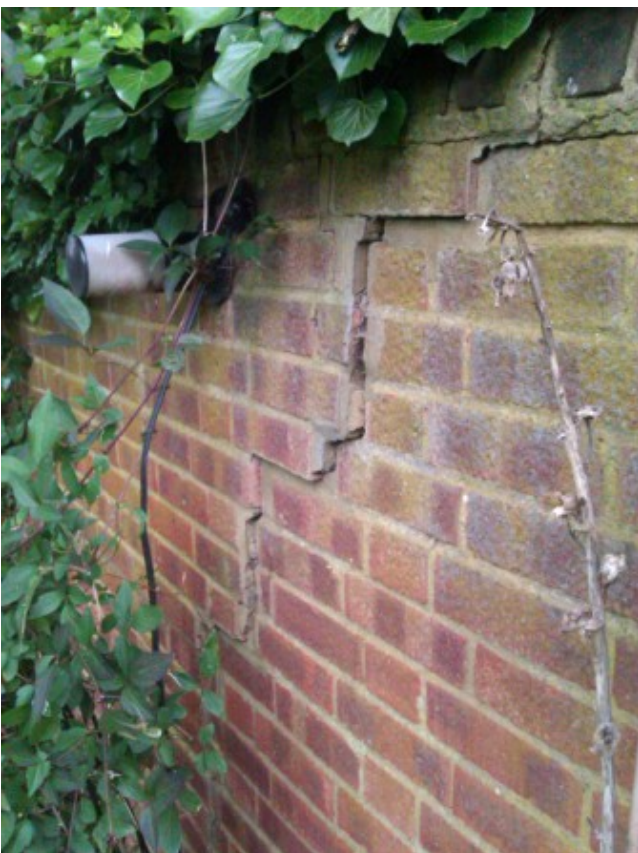
Fig. 3: Alternative view of damage.

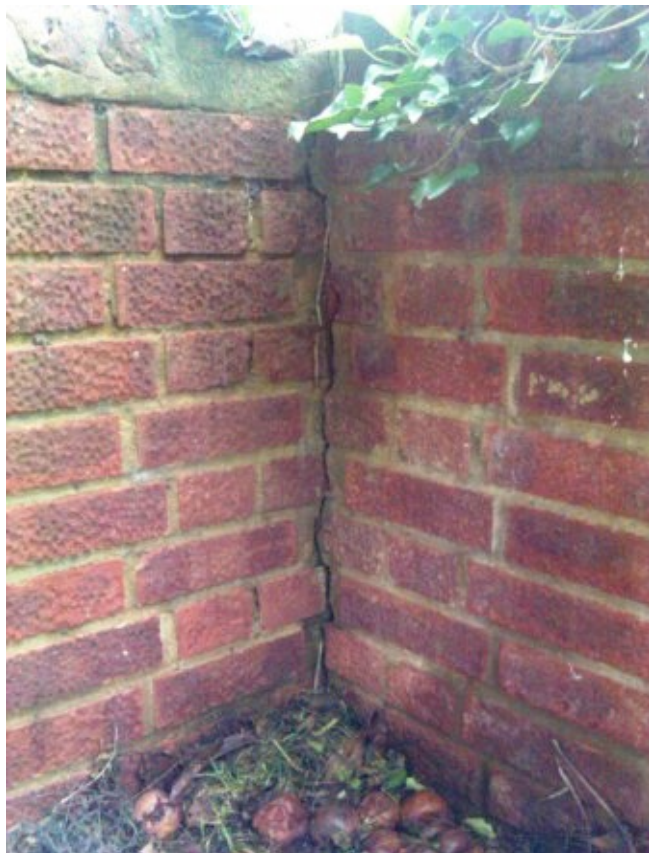
Fig. 4: Crack to north west of T1 where the damaged wall (left) meets the undamaged wall at the rear of xxx (right).

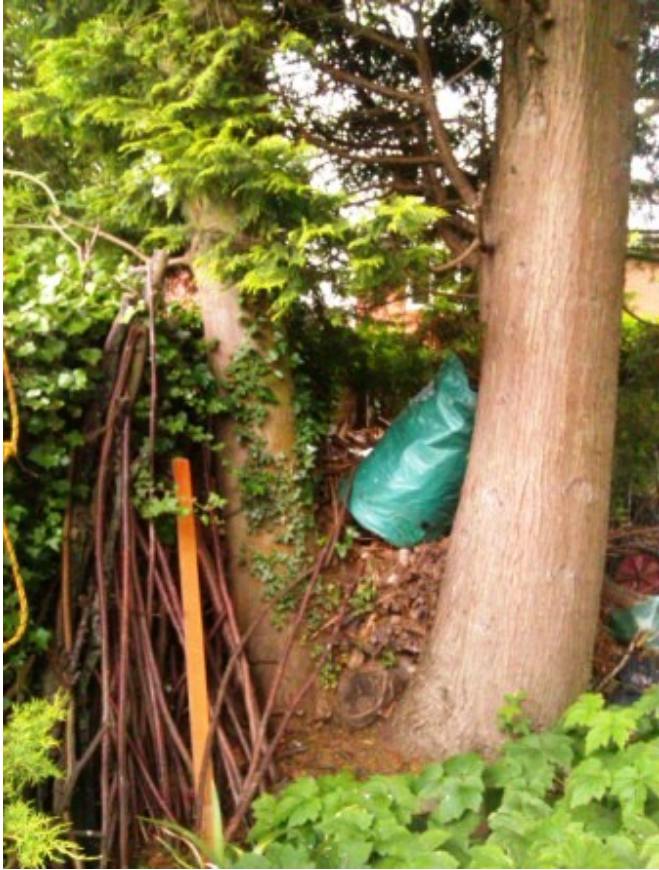
- The presence of wood, rubble and other materials between the tree and the wall have the effect of transmitting forces generated by the wind and the lean of T1 to the wall under light to moderate wind conditions. As T1 grows, and the stem thickens, the forces generated will increase.

Fig. 5: General view of the base of T1 (left) and T2 (right) showing the presence of wood etc.

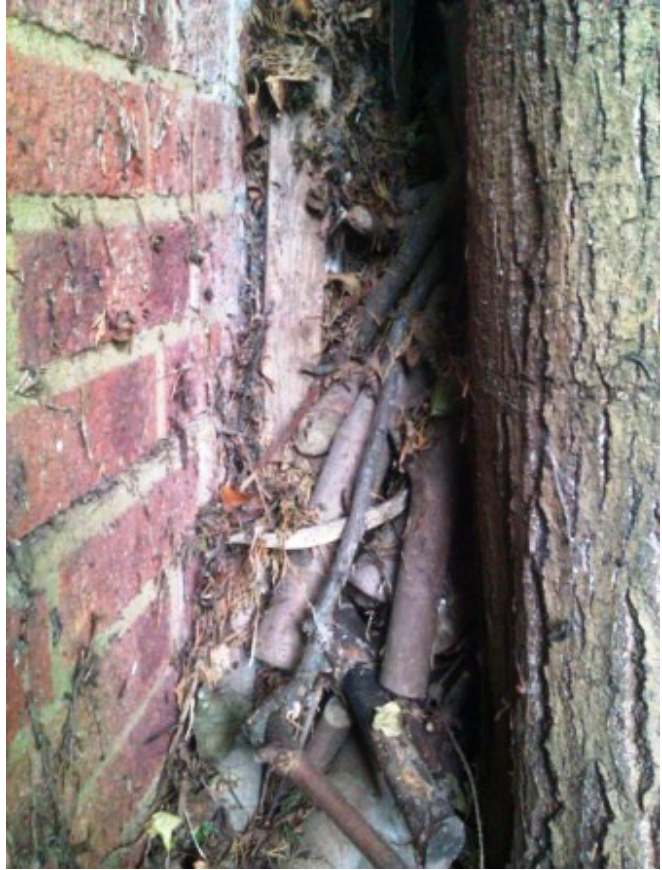
Fig. 6: Close-up after removal of hazel rods showing wood packed in between T1 and the wall.

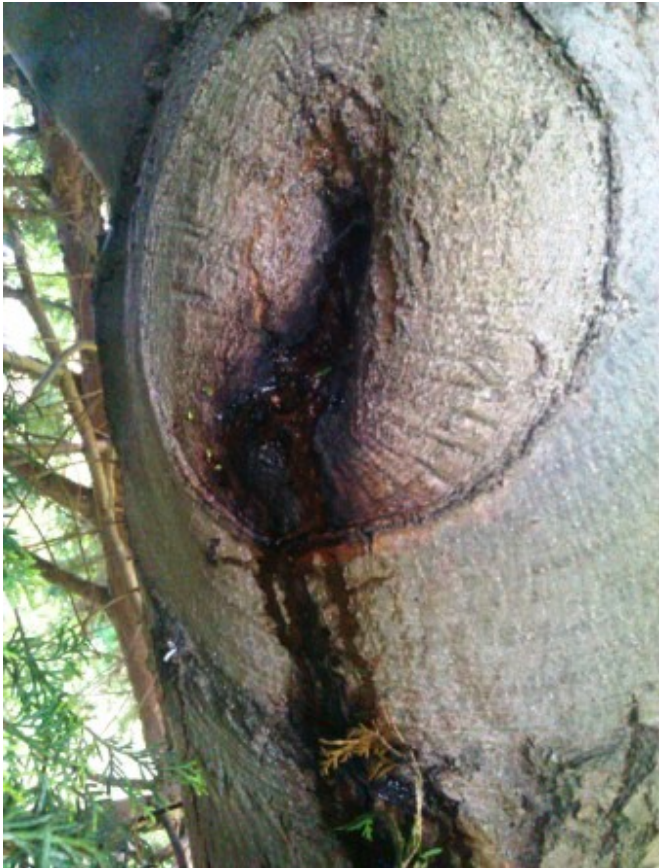
- A black tar-like exudate was noted emanating from pruning wounds on the south west side. No wood decay, hollows or cracks could be found. The severity of this exudate has been noted to increase in the summer months and lessen during the winter. The most likely explanation is the loss of sap from bark / cambium injured by pruning. Bacterial infection cannot be ruled out.

Fig. 7: Black tar-like exudate from old pruning wound on T1. This is thought to be sap of minor significance.

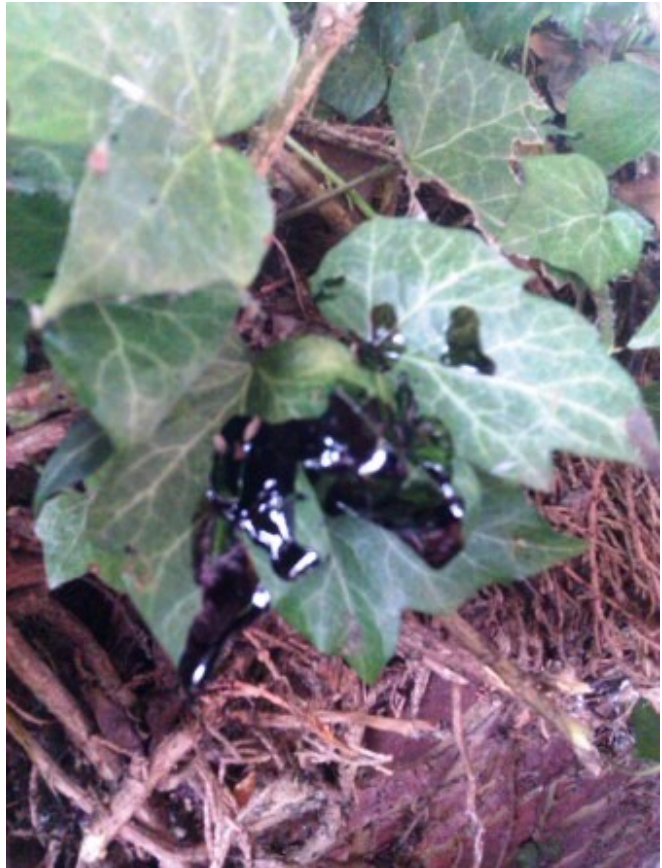
Fig. 8: Droplets of exudate on ivy leaves below T1.

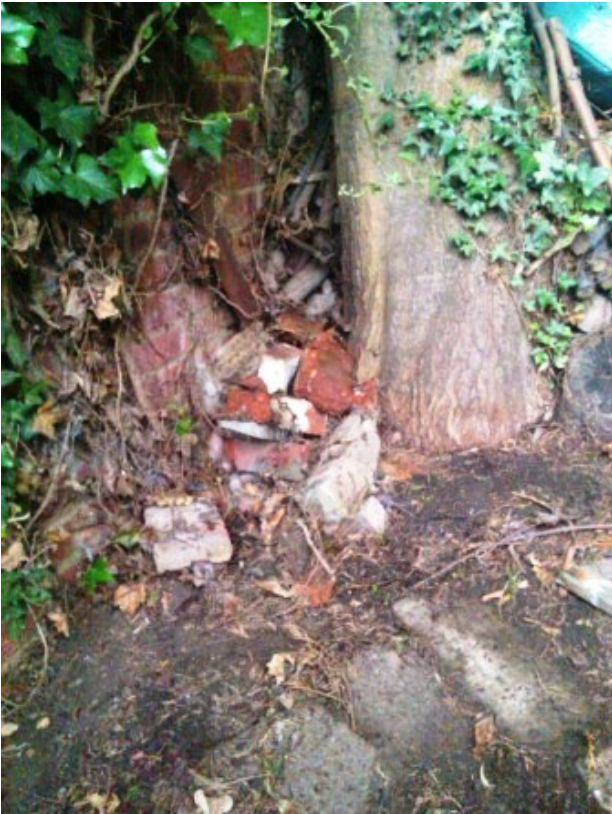
Fig. 9: Close-up showing rubble below T1.

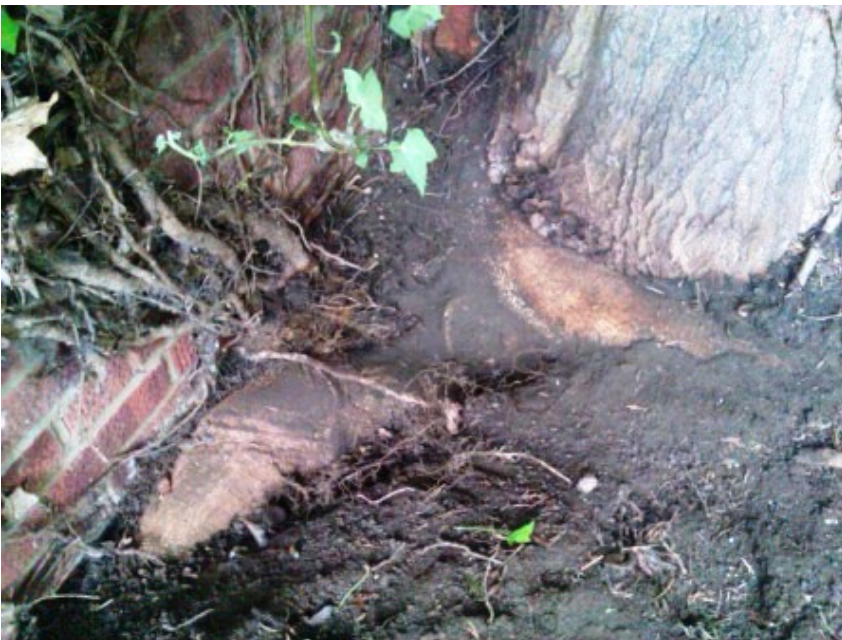
- The ground around T1 was heavily obscured by wood, paved surfaces, rubble, garden waste and the close proximity of T2.
- The area between the tree and the wall to the south and east of T1 was cleared and the soil dug back to reveal the roots.
- A large structural root was found to abut the wall just below the surface to the south east. The root appears to project parallel to the wall for some distance. Smaller roots were observed projecting in a range of directions.
- A further large structural root was found to project towards the north in a girdling fashion.

- Structural tree roots do not appear to be pushing the wall over at this stage.
- Smaller conductive and absorptive roots are likely to pass under the wall and into the garden of xxx.

Fig. 10: Close-up showing root abutting the boundary wall and a girdling root passing northwards.
