# Tree survey at xxx.

Prepared for xxx.

15<sup>th</sup> October 2013

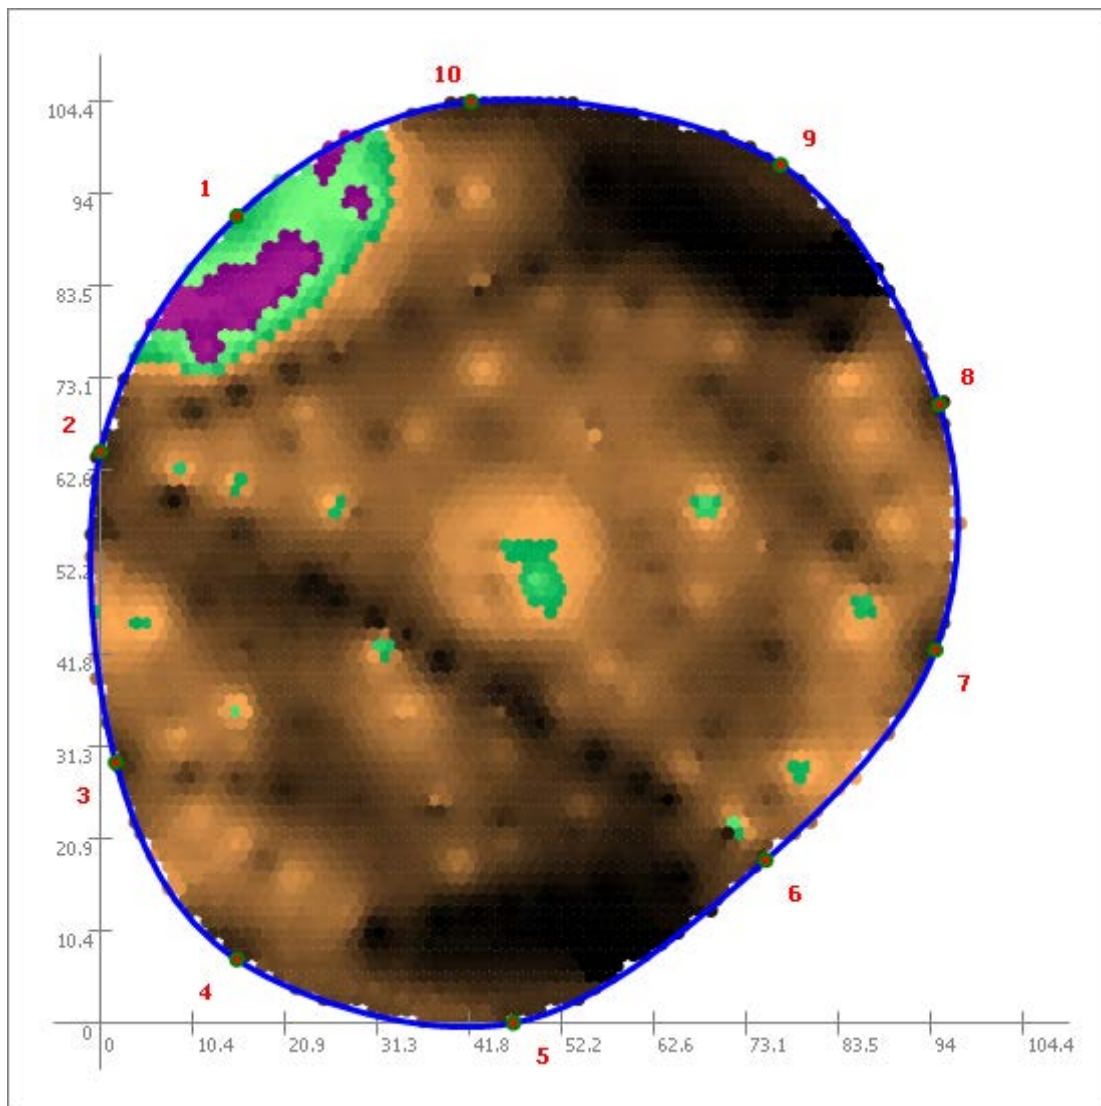
### 3.4 Sonic tomography

- The area of decayed wood is associated with the location of the Ganoderma brackets.
- There is sufficient sound wood in the stem to support the crown of the tree.
- The condition of the roots has not been determined by this scan.

- Picus results show absence of significant decay in lower main stem but the size and number of *G. resinaceum* brackets suggests the presence of advanced decay.

- The seat of infection can therefore be expected to lie in the main structural roots creating the possibility that the tree could be destabilised in high winds (windthrow). However, the healthy condition of the crown suggests that root function has not been significantly compromised at this stage.

- Main structural roots should be examined by air spade excavation and visual assessment within 1 month.
- Excavation should be carried out by trained and certificated operatives according to the principles of BS3998:2010.
