# **BS5837:2012 Tree survey at XXX**

**Prepared for xxx**

15<sup>th</sup> November, 2013

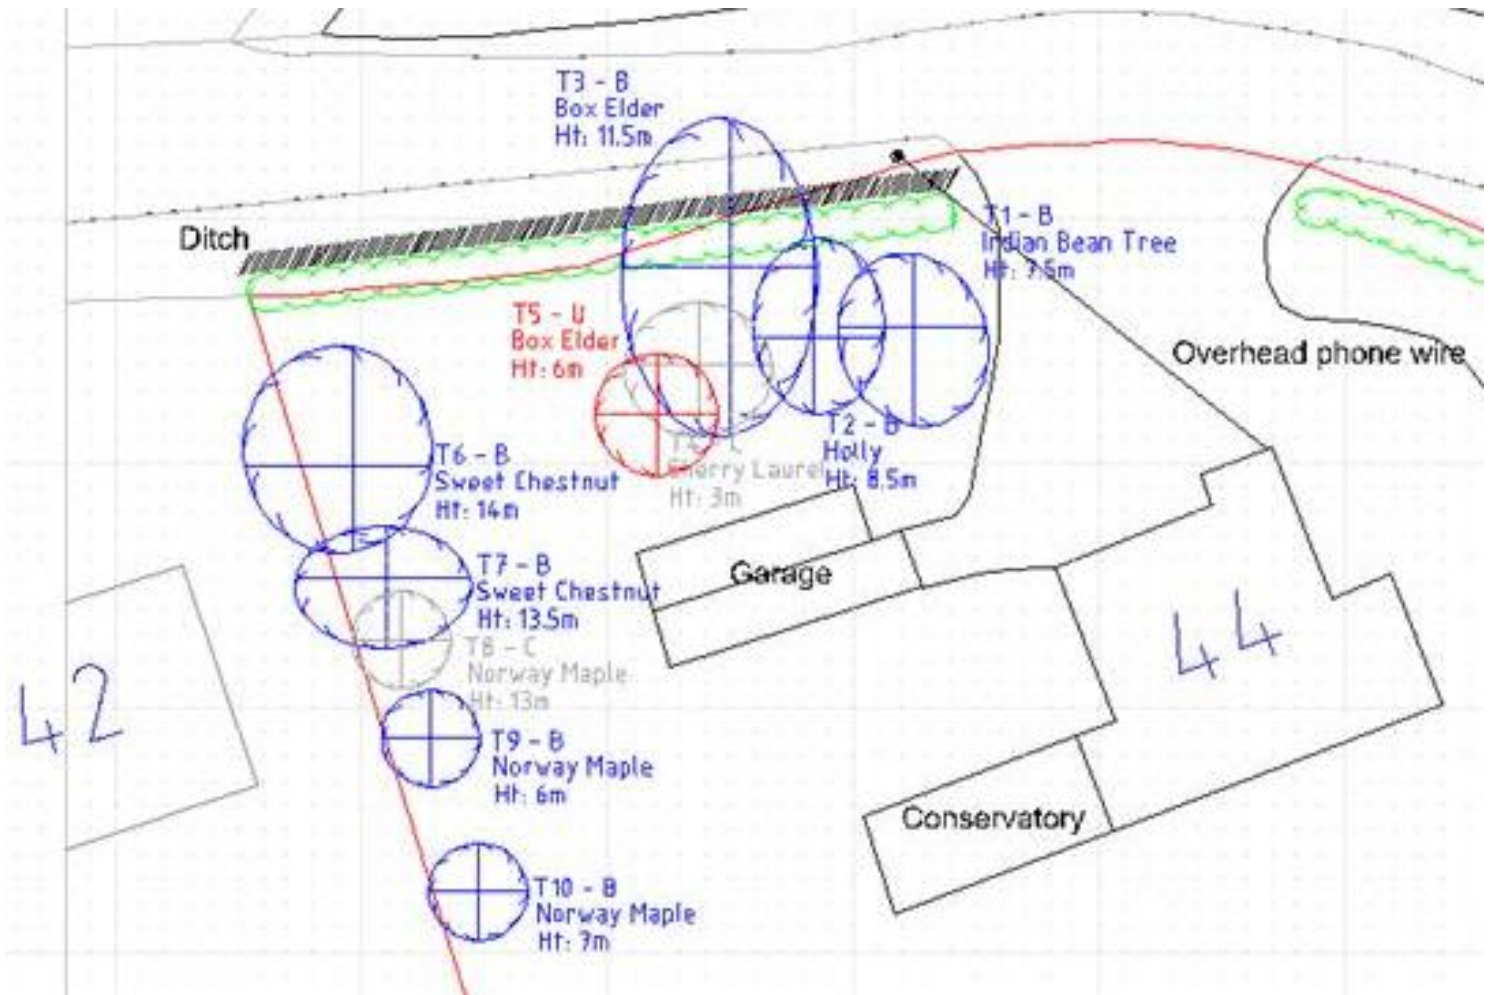
3.2 Site plan:

T	Species	H	D	Spread	Clr	Age	P Cond	S Cond	Rec	ERC	Cat
1	Indian Bean Tree (Catalpa bignonioides)	7.5	340	N 3 E 4 S 4 W 2	1	M	Good	Good	Lift crown to 2.3m	40+	B1
2	Holly (Ilex aquifolia)	8.5	269	N 4 E 3 S 3 W 2	0	EM	Good	Fair	Remove saplings, lift crown to 2.3m, reduce height by 2m	40+	B2
3	Box Elder (Acer negundo)	11.5	410	N 6e E 3 S 7 W 5	2	M	Good	Fair - decay cavity	Reduce crown by 40%, Lift crown to 5.3m over road	20+	B1
4	Cherry Laurel (Prunus laurocerasus)	3	131	N 2.5 E 2.5 S 3 W 3.5	0	M	Good	Good	Trim or cut back hard	20+	C2
5	Box Elder (Acer negundo)	6		N E S W	1.5	M	Poor	Poor - heavily leaning, decayed	Remove	<10	U
6	Sweet Chestnut (Castanea sativa)	14	490	N 5.5 E 3.5 S 3 W 4e	2	M	Good	Good - potentially wind exposed	Reduce crown by 30% & deadwood	40+	B1
7	Sweet Chestnut (Castanea sativa)	13.5	360	N 2 E 4 S 3 W 3e	2	M	Good	Fair - potentially wind exposed	Reduce crown by 30% & deadwood	40+	B1

8	Norway Maple (Acer platanoides)	13	540	N E S W	4	M	Good	Fair - decayed pollard knuckle	Repollard within two years	20+	C1
9	Norway Maple (Acer platanoides)	6	360	N E S W	2	M	Good	Good	None	20+	B1
10	Norway Maple (Acer platanoides)	7	350	N E S W	3	M	Good	Good	None	20+	B1

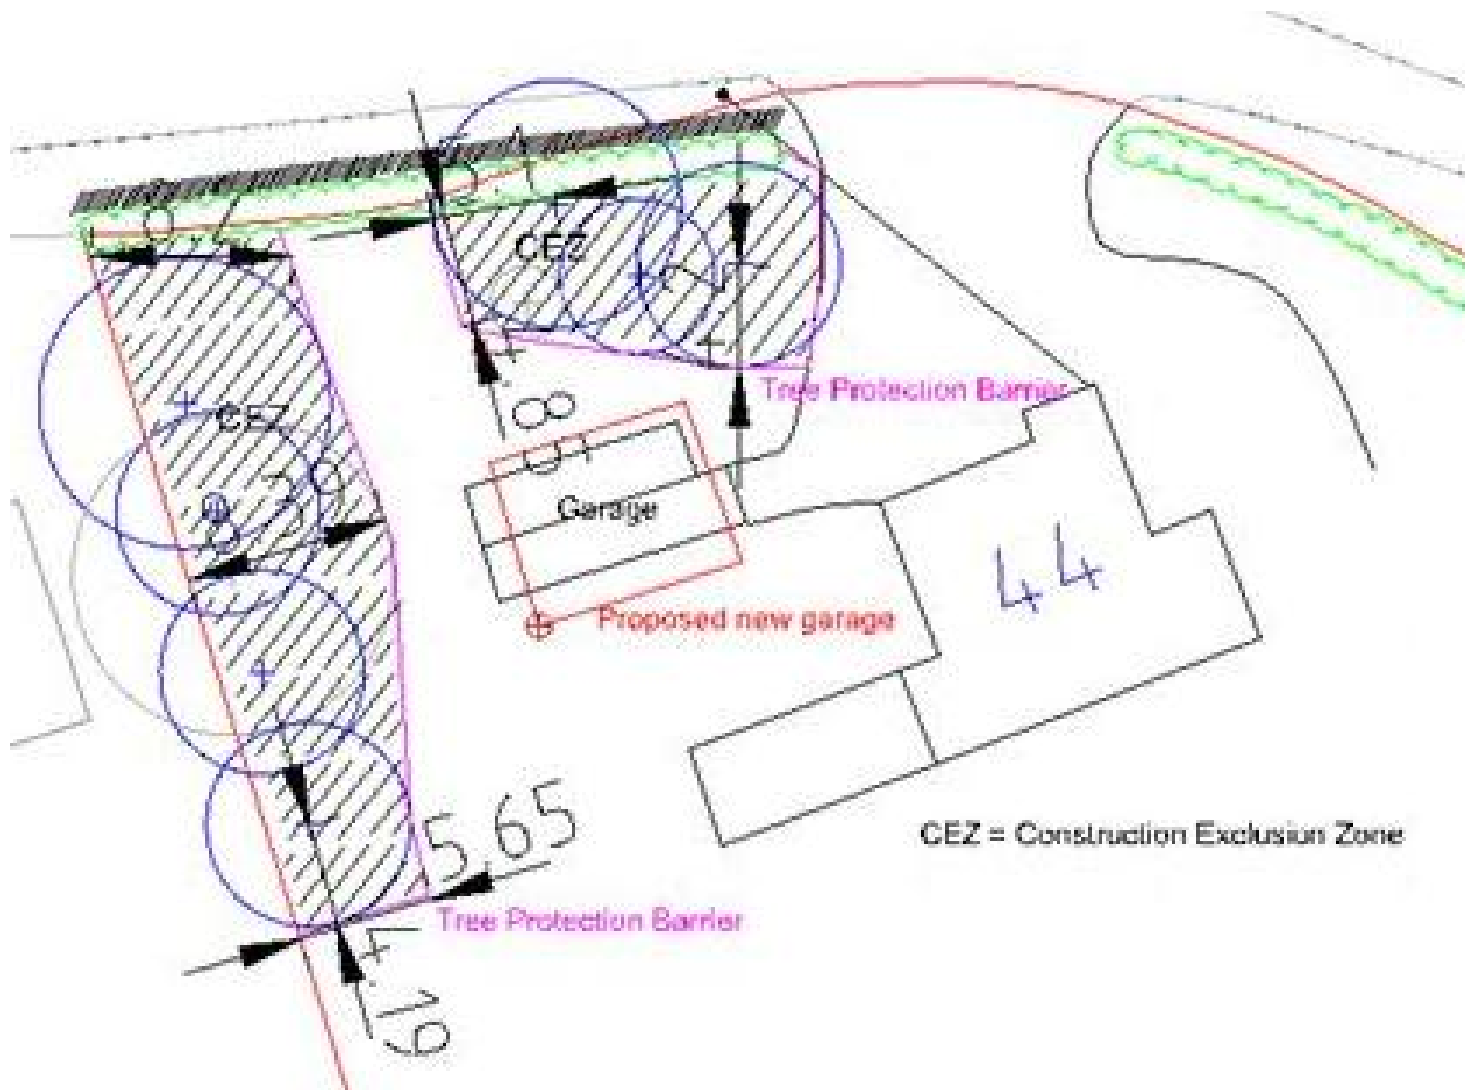
- There are no particular conflicts between the proposed building development and the trees surveyed.
- Root protection areas and the above ground parts of the trees can be protected by erection of a mesh panel protection fence along the lines shown in the Tree Protection Plan (see below). Panels should stand in rubber feet, be clamped together and labelled with all-weather signage reading 'Construction Exclusion Zone – Keep Out'.
- A full Arboricultural Method Statement for tree protection can be provided, if required.
